Bridge of the Month No 40, April 2014 Hereford Old Bridge

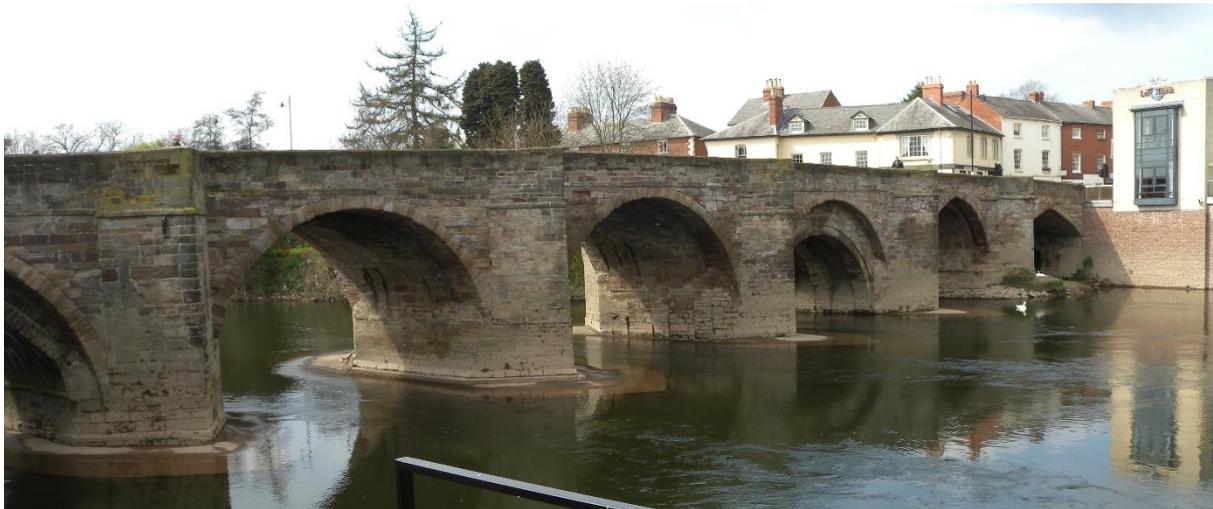
Some time ago (the date stamp on the photographs suggests almost exactly 4 years) I visited Hereford to see a FlexiArch erected. While there I found time to look at, and take a few photos of, [the mediaeval bridge](#). And when I look at that Googleplan view, the first thing I notice is that the bridge is skew, not severely so but enough to count as skew.

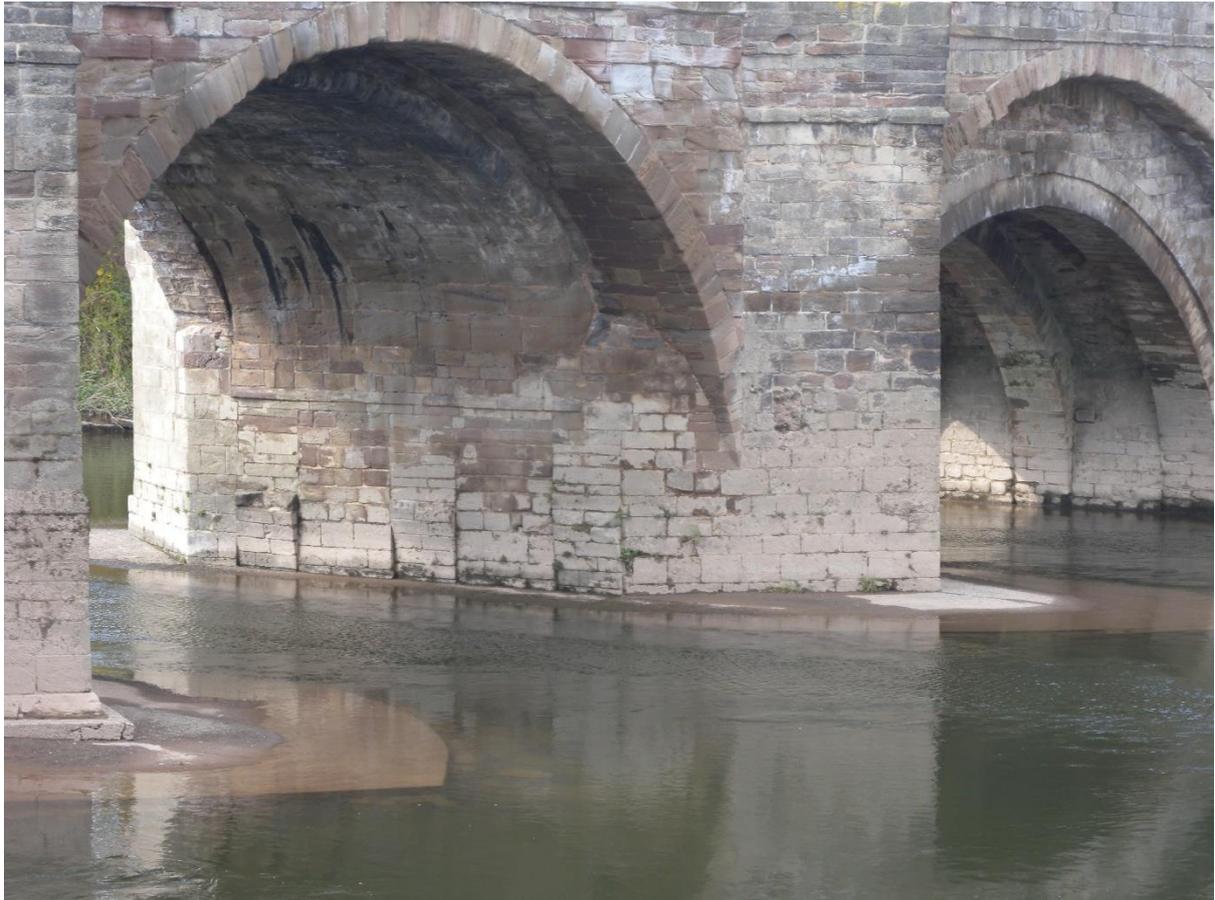
There is quite a mixture of spans here. The oldest are probably the semi-circular ribbed arches to the left and third from the right.

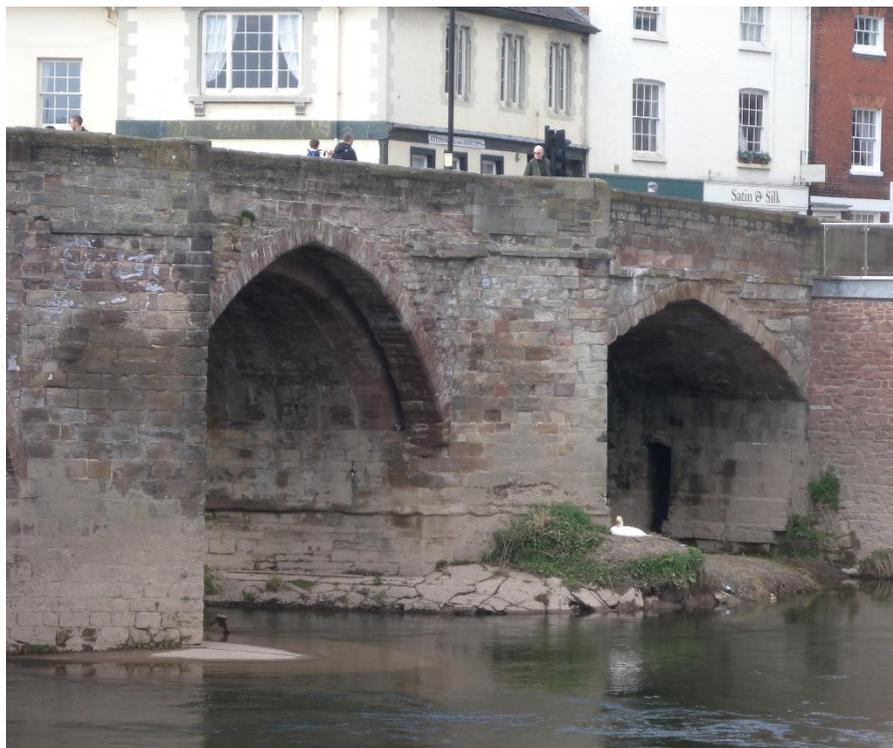
A closer look shows vestiges of ribs in the higher spans.

This picture also shows how the bridge has been widened by springing additional arches off the sloping face of the cutwater.

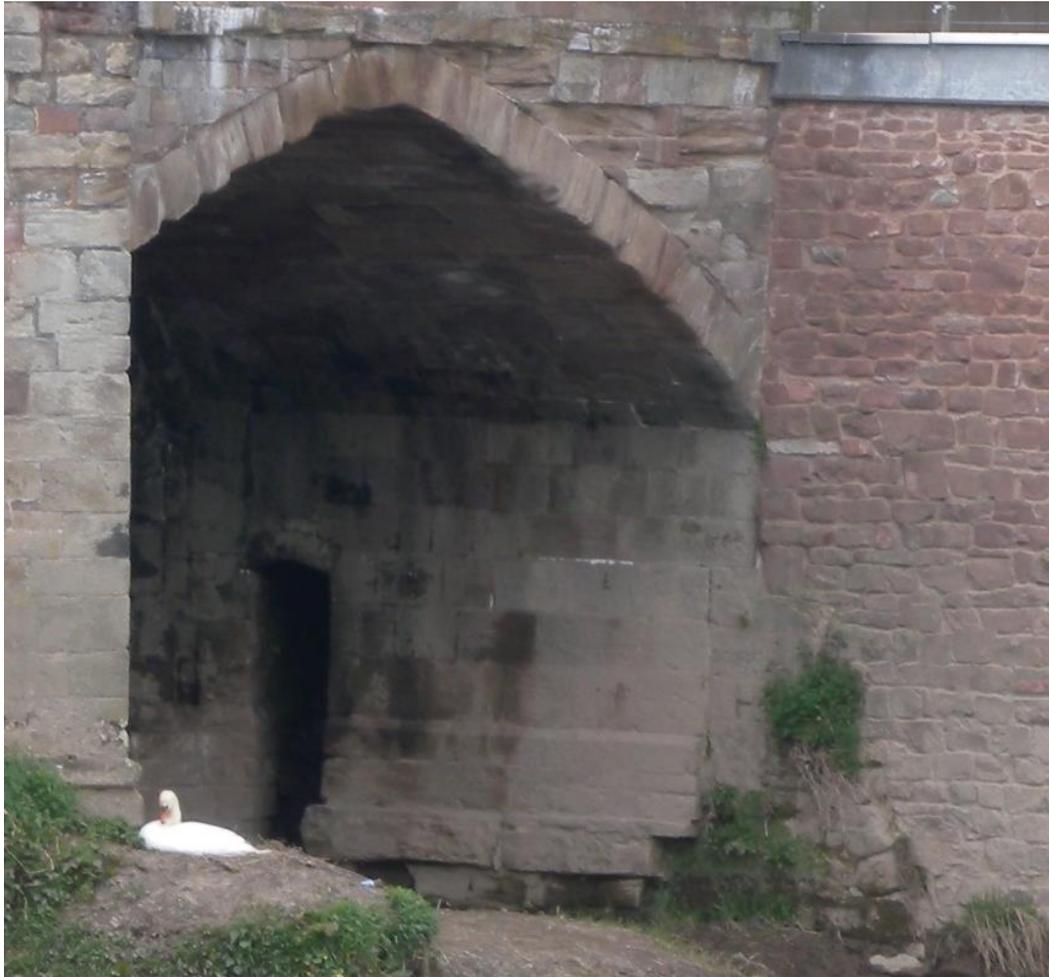
The north end of the bridge, shown above also gets noticeably wider. That means that the side shown here is more skew than the rest of the bridge.

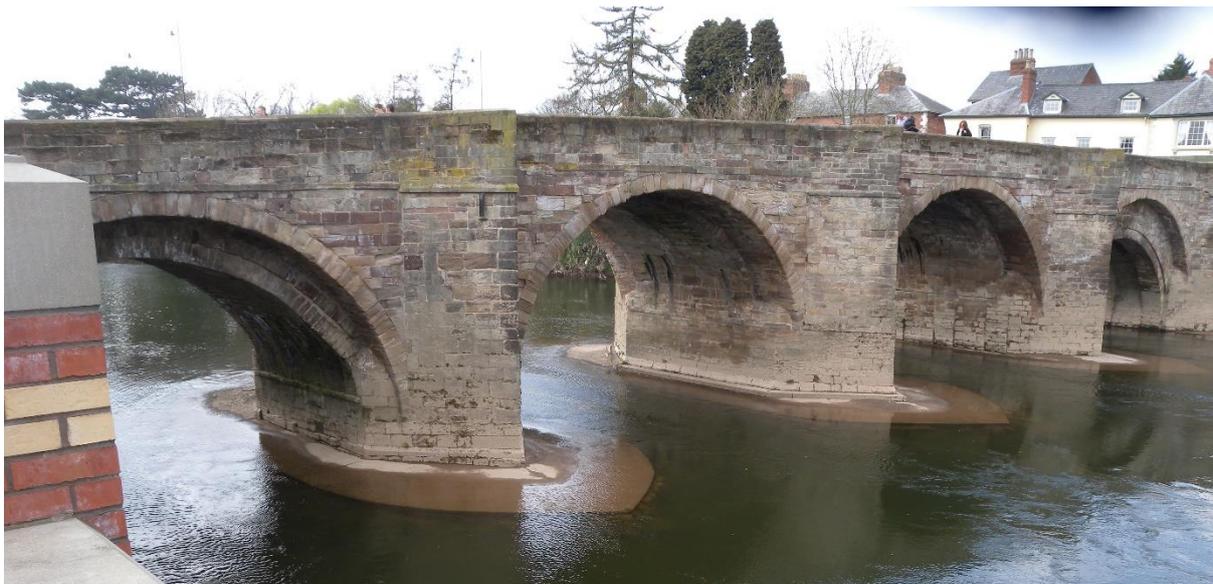
A closer look confirms that the edge strip is a later addition.
