## Bridge of the Month No24 December 2012 Raymouth Road

# Raymouth Road Viaduct, London

Bill Harvey Bill Harvey Associates Ltd and OBVIS Ltd

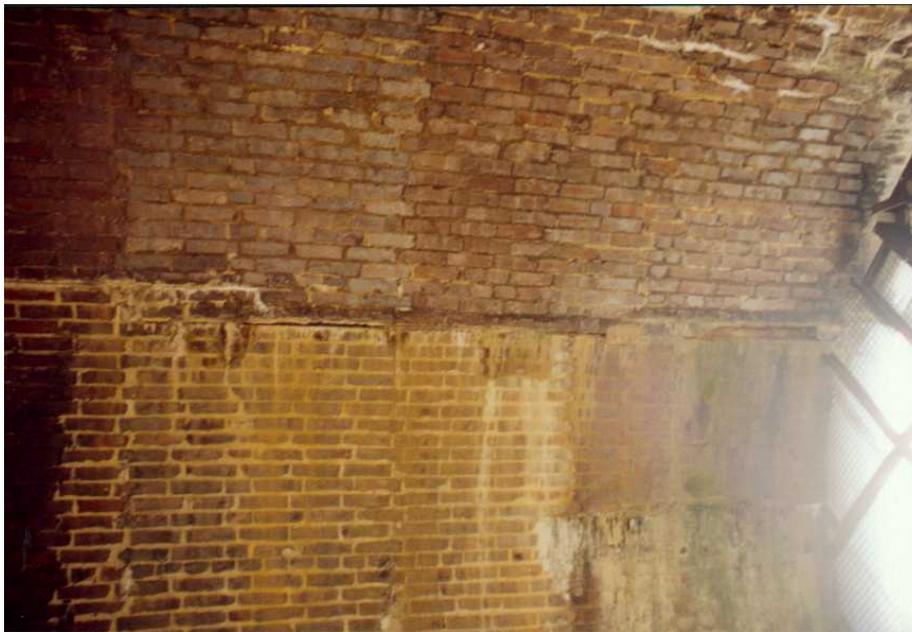
It is evident here that the line of the crack also marks a significant change in the condition of the brickwork. Some of that is the result of repointing but the water runs clearly emanate from the crack.

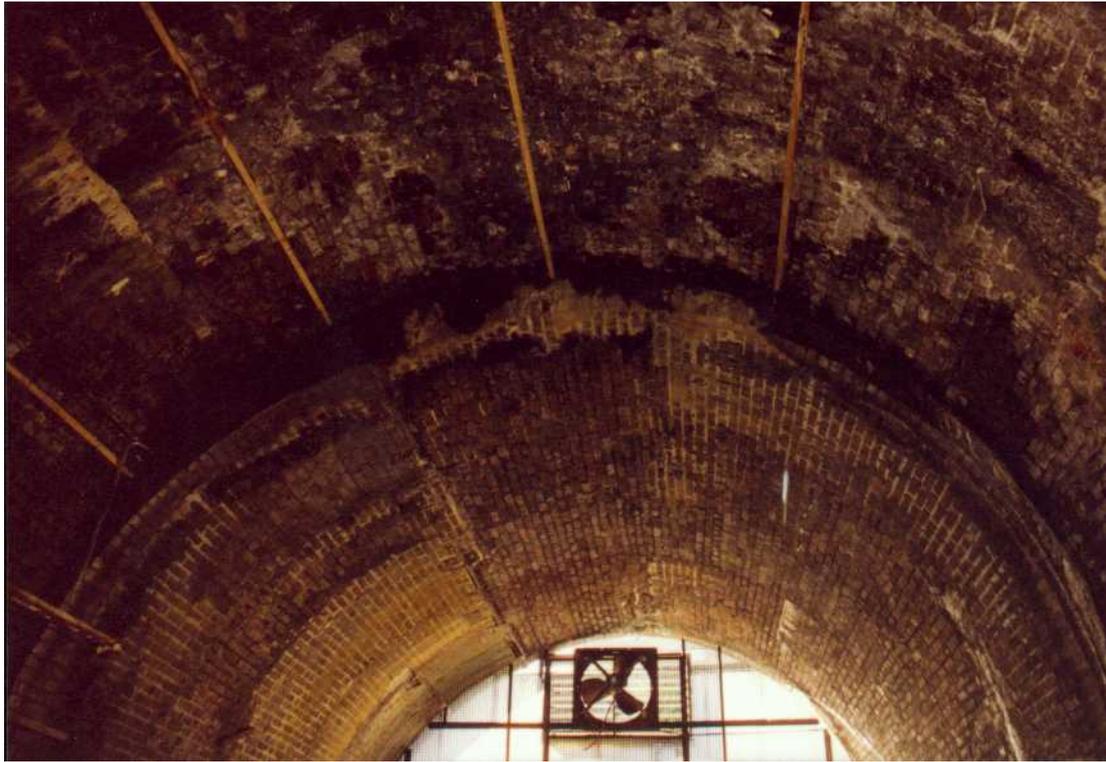
The join between two parallel viaducts is evident here, as is the angularity of the arch. There are kinks just to the right of the crown and, more obviously, to the left of the fan frame.

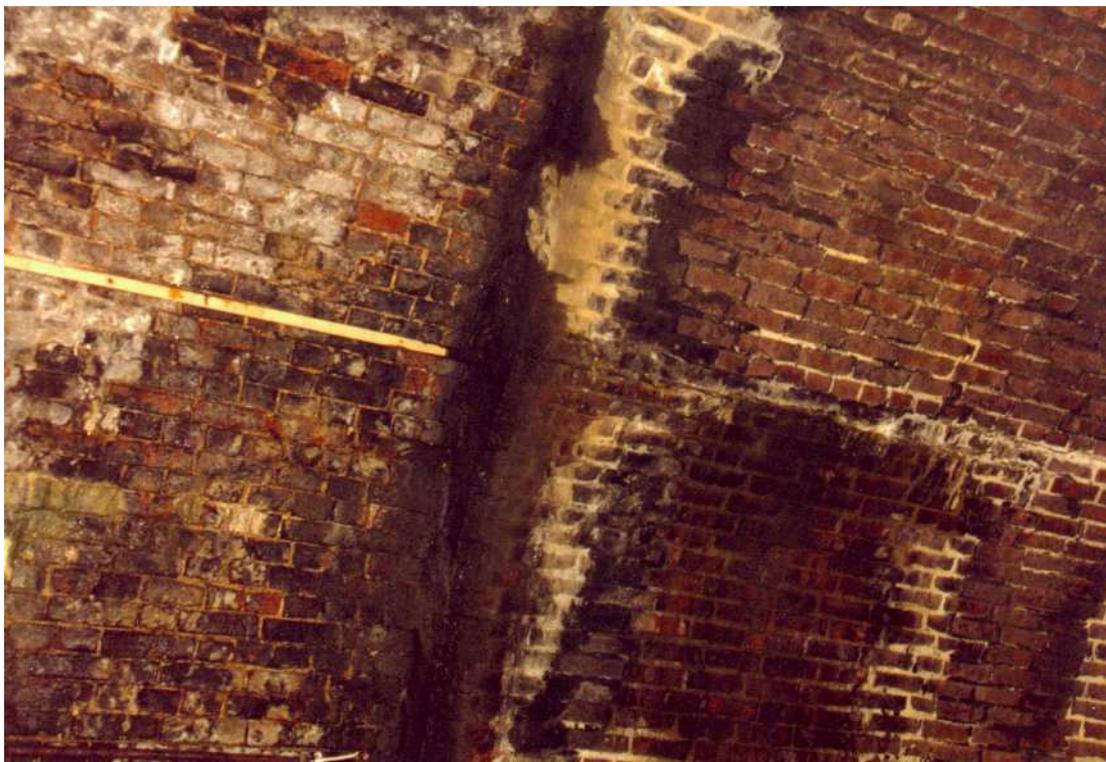
The inner end of the hinge.

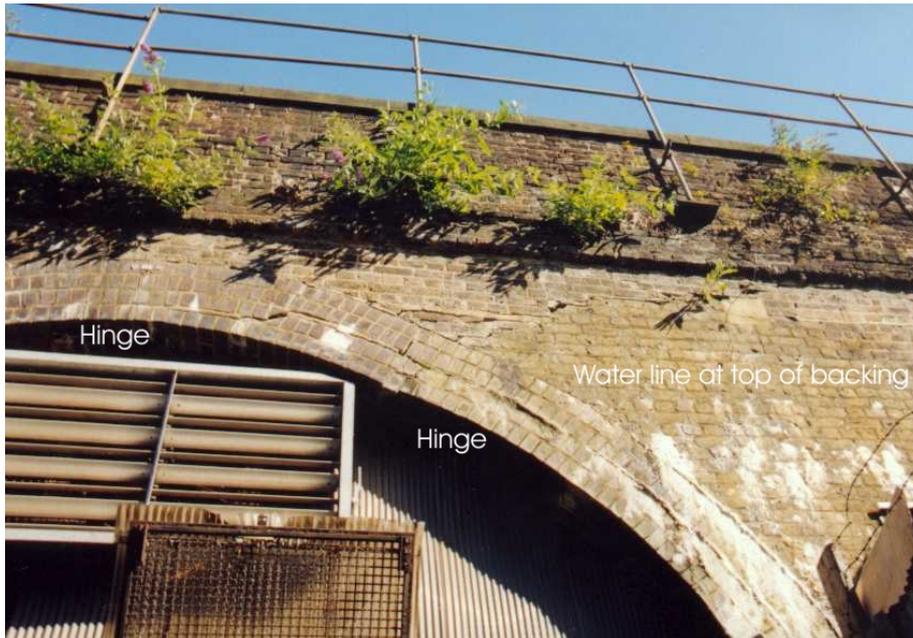
Here, and below, you can see:

The hinge positions. Note that the extrados and intrados in hinges are at the same level so settlement can take place without additional thrust developing.

The water line marking the top of the backing.

The crack working slowly up to the string course. Masonry above the crack is arching over the gap.

Measurement indicated that the pier had dropped 100mm or thereabouts. The track had been relevelled and the movement remained undetected for years.

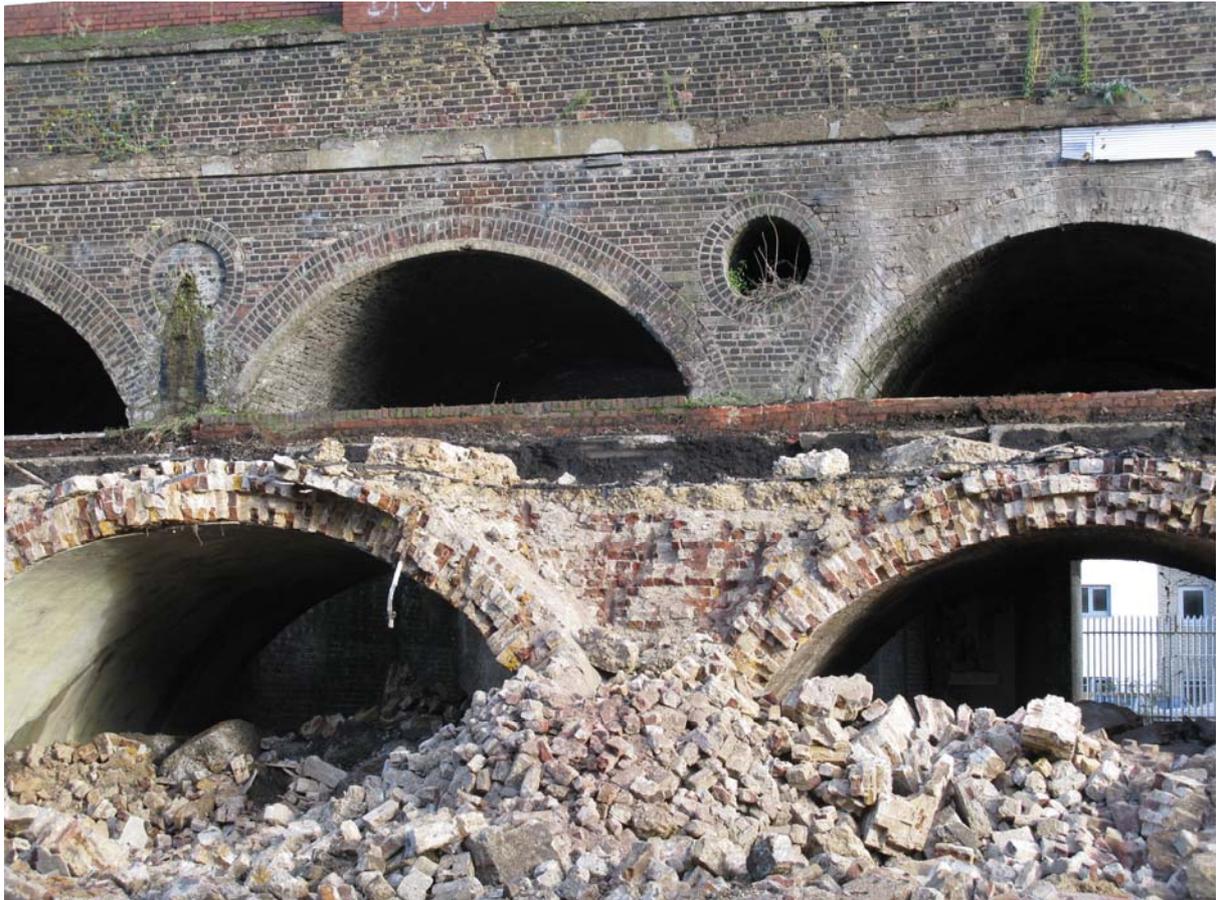
The arch being demolished, below, is part of a nearby viaduct.

Here we have solid brickwork backing topped with a concrete layer to produce a smooth wave form and then waterproofed with asphalt. The asphalt appears to be topped with concrete too. Note the voided spandrels in the viaduct behind. We can be confident here that the masonry is solid to level with the extrados of the ring. Where a void has been closed, it appears to be full at least to the half way mark.

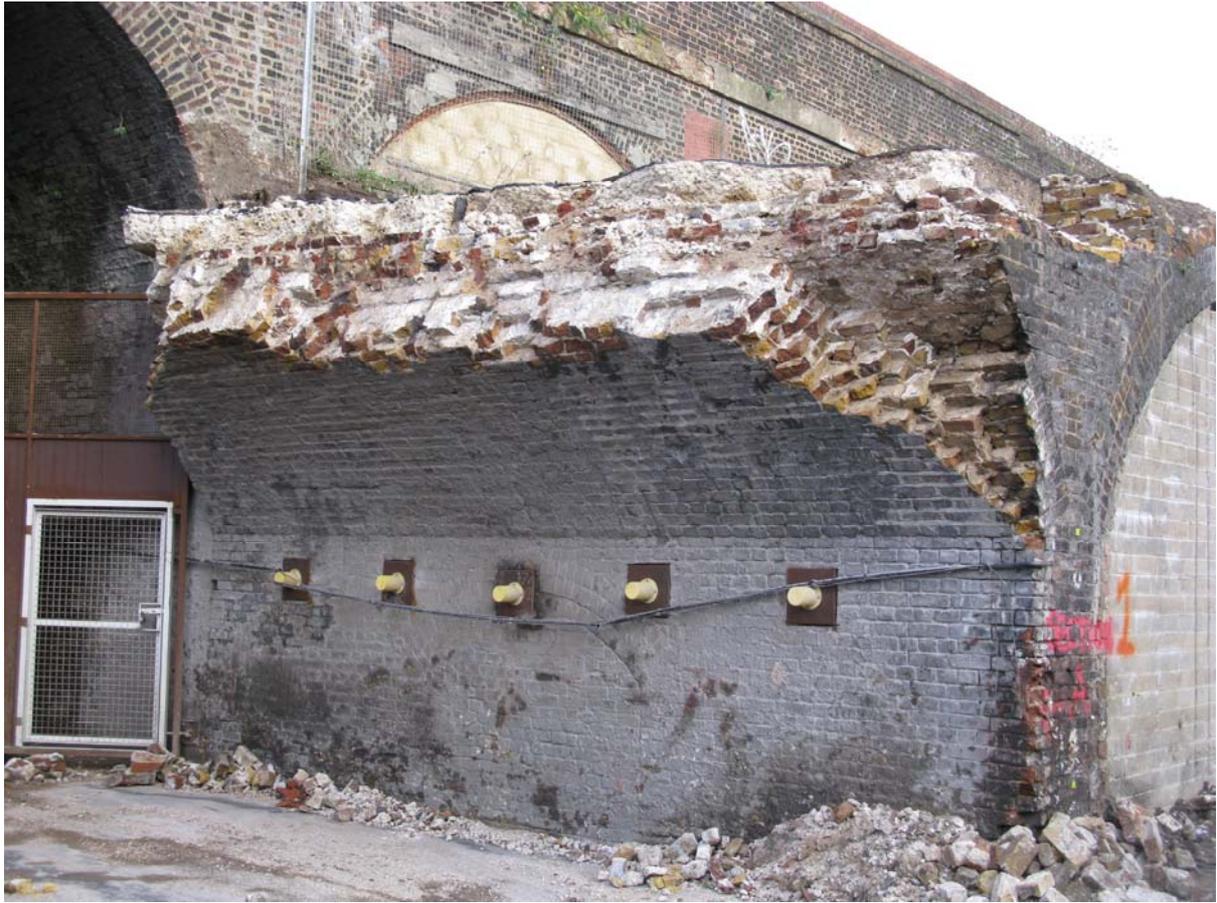
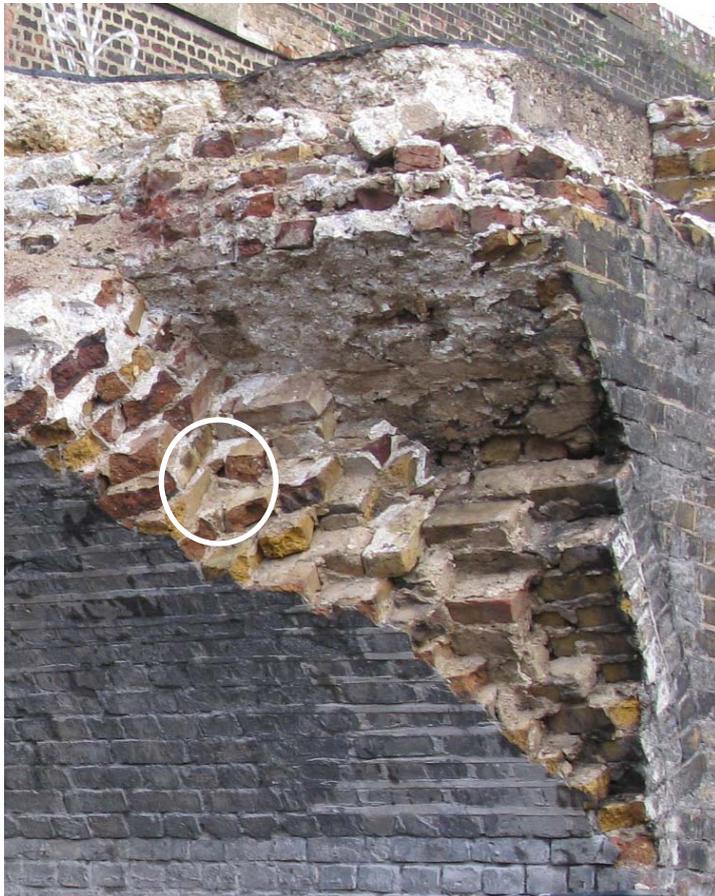
A closer look at this picture shows a lot of interesting detail. The rings appear to be fully bonded except on the exposed edge. Near that edge, though, the 2<sup>nd</sup>/3<sup>rd</sup> layer seems to be very short of mortar and looking elsewhere there are empty frogs even in the arch. The ringed empty frog looks as though it shows a brick on edge. It might be that the ring taper was made up in this way.
