Bridge of the Month No25 January 2013 Bridge 26

Now here is something different.

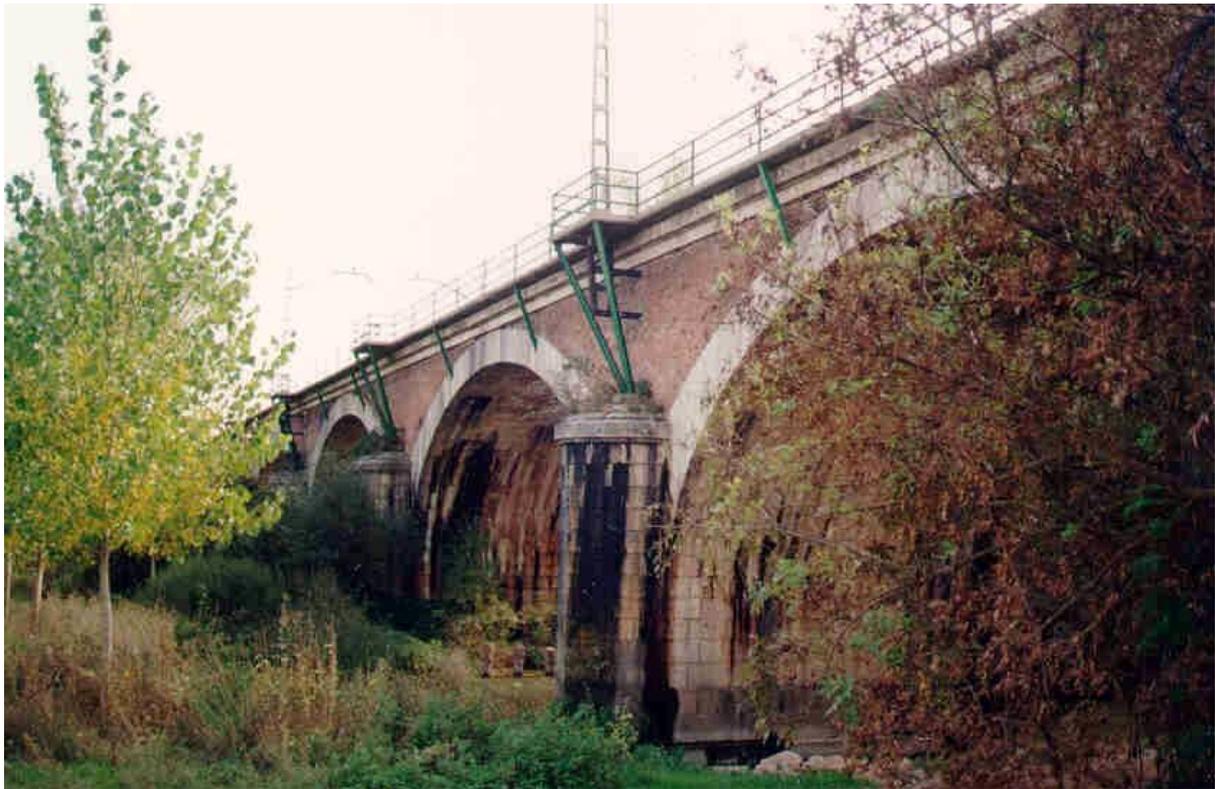
The bridge number marks this out as a railway bridge but even without that, the style is obviously of the railway era and the overhead cables are a clincher. My guess would be Austria.

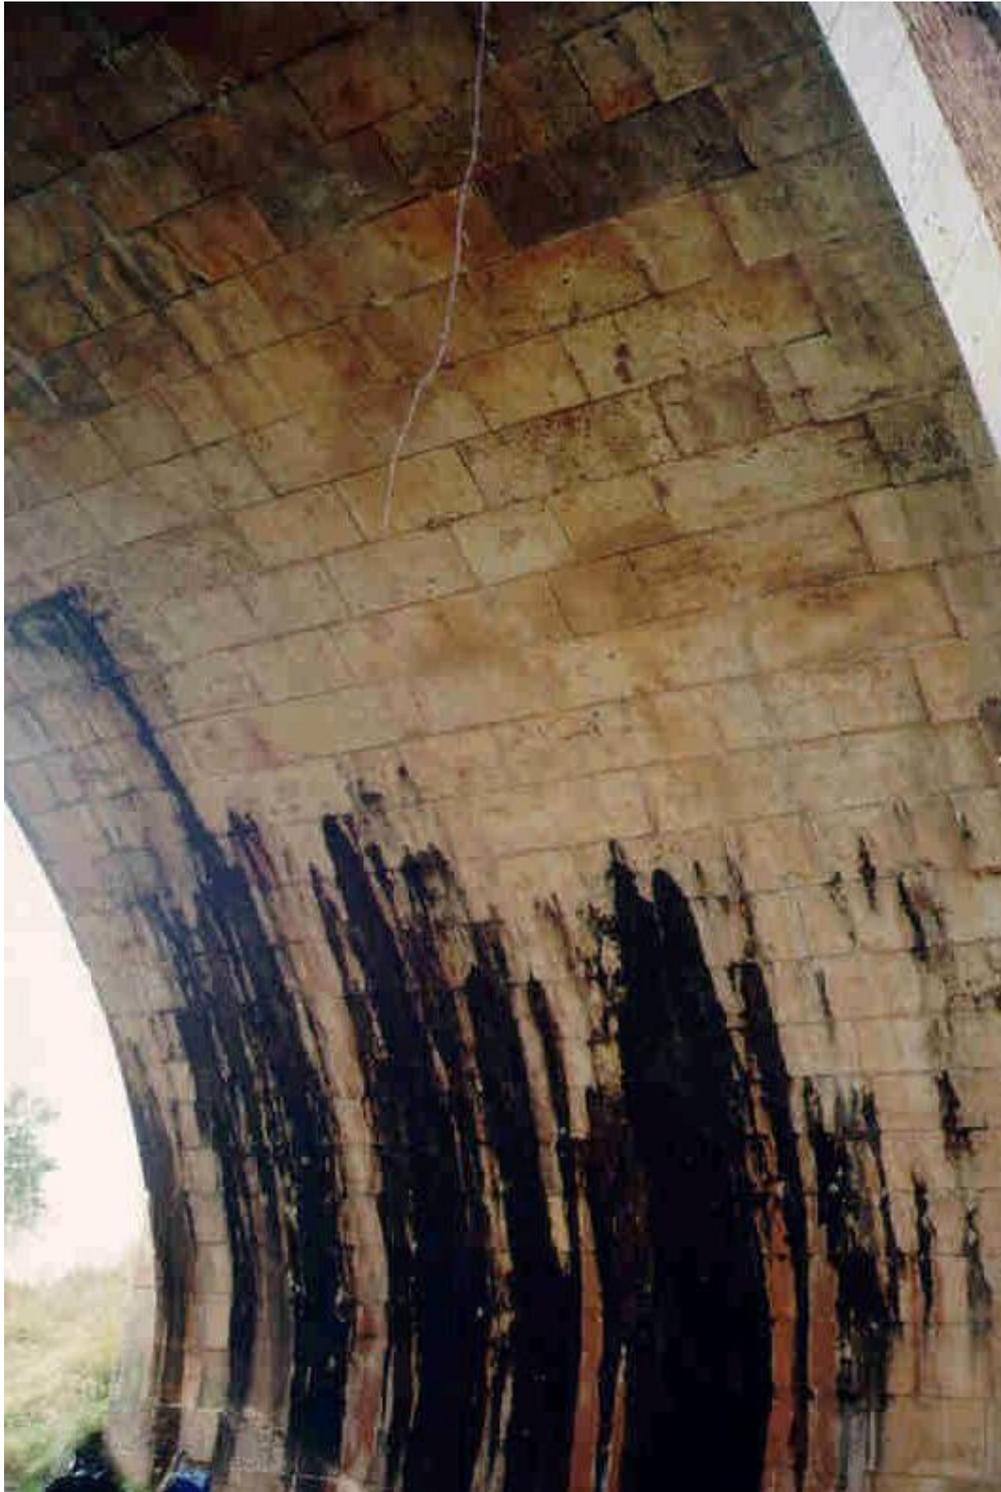
Look underneath the arch and there are pronounced water runs from well up the curve. Notice, however, the highest one at top left which is obviously of a different set. That isn't a crack but a bit of vegetation hanging down.

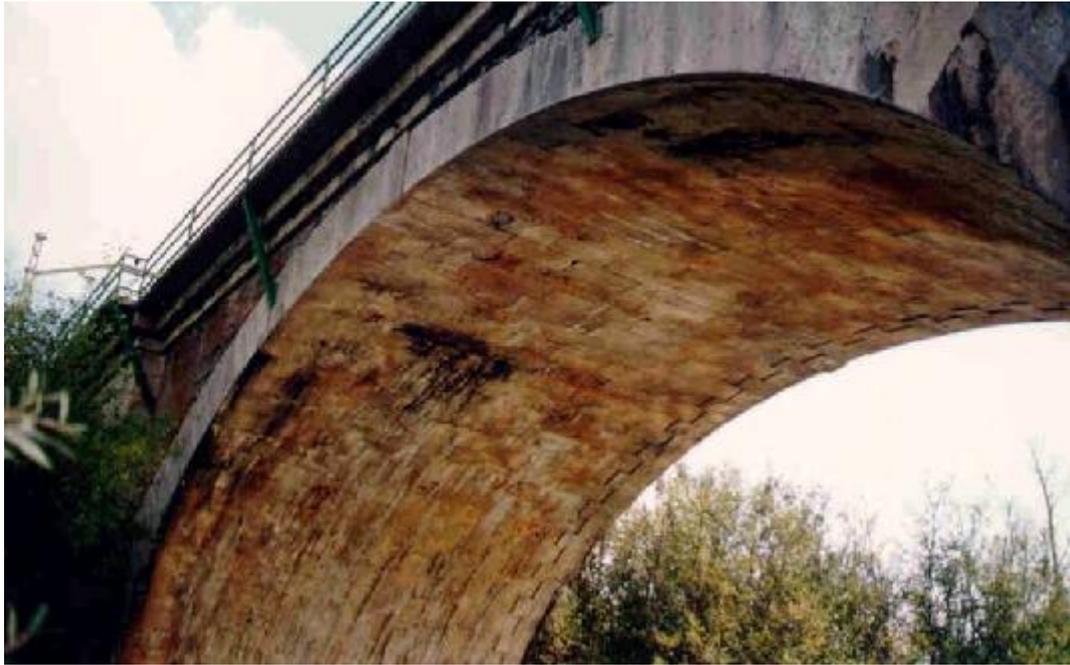
A higher level photo shows that the top line of penetration is very high, perhaps only 1.5m away from the crown. All this is particularly visible because the stone is pale but even in darker stone or brick these signs are often there if you look.

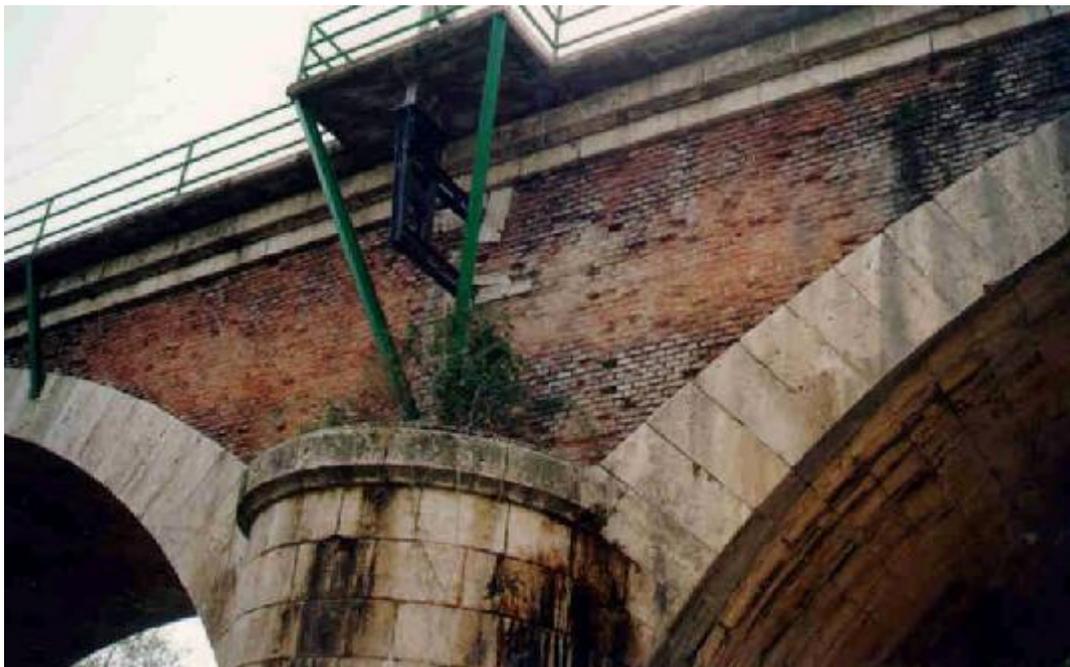
A look at the spandrel wall shows a band of weathering in the brickwork. Look carefully at the bottom right and you will see that the bottom edge of this corresponds with the lower layer of water runs in the soffit. Look back to the first picture and the correspondence of the water runs and the weathering levels in the brick becomes obvious.

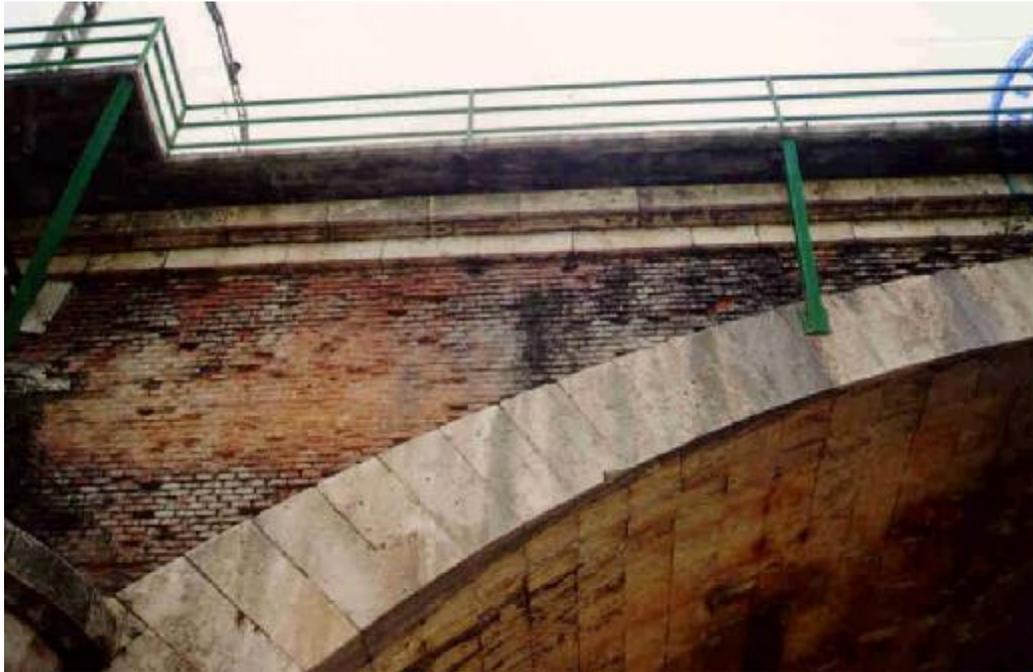
A closer look shows more of the nature of the weathering of the brick. It also shows clearly that the expressed ring (at least) is tapered, beautifully fitted and has tight joints.

The banding here, and in the arch ring, corresponds well with different levels of internal construction such as is shown in the part demolished bridge near St Pancras (below and BoM).

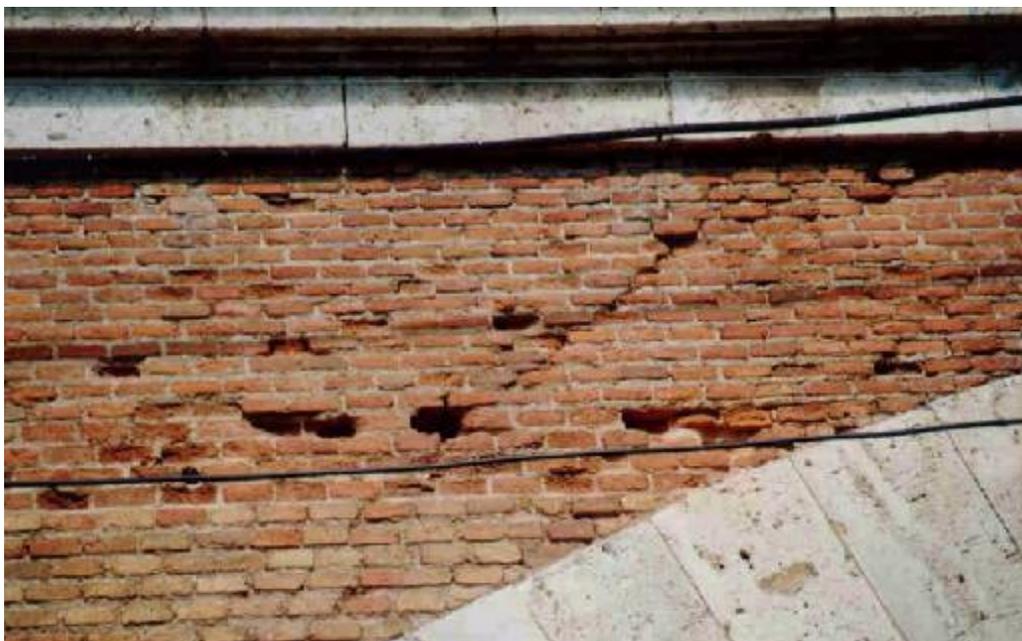
This, yet closer look is obviously a different span. The line at which the weathering starts is very clear. There appears to be a diagonal crack in the brickwork but it might just be a construction joint, perhaps where the skilled bricklayers worked away from the ring and produced an easy edge for the improvers to work from.
