## Bridge of the Month March 2013 The Causey Arch

The Causey Arch was built in 1725-7. It has reasonable claims to being the first railway bridge in the world and for 30 years was the longest single span in the UK at 105ft (OK 32m). The mason was Ralph Wood. It was eventually passed by the new Bridge at Pontipridd by William Edwards.

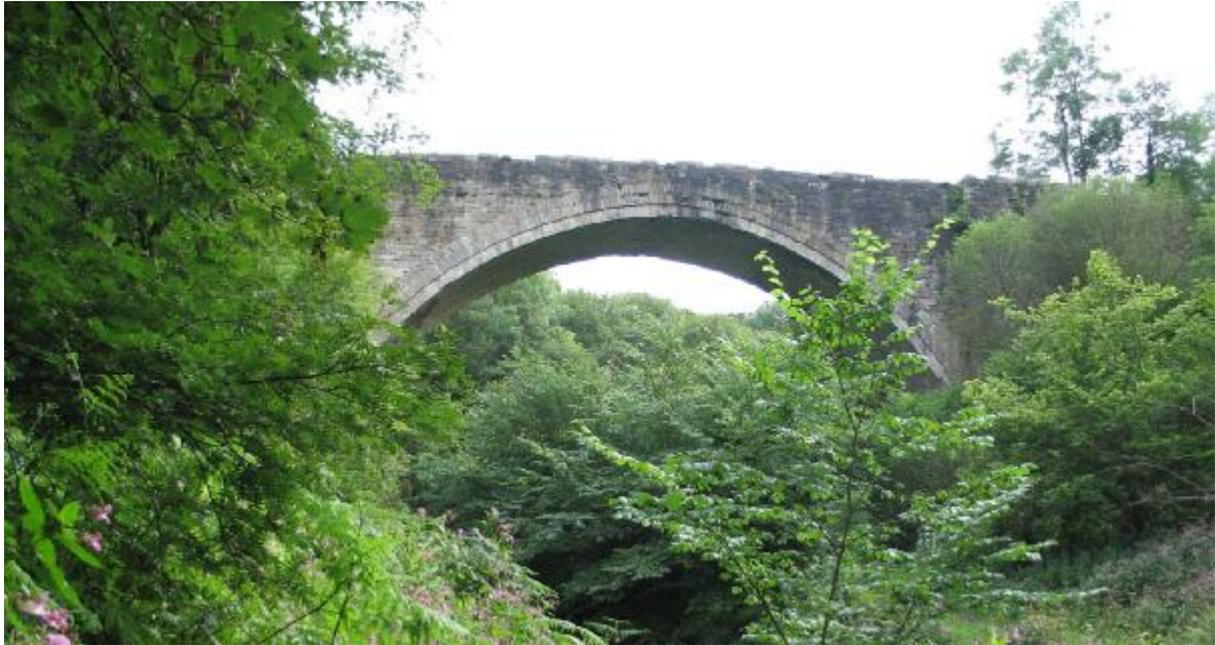
It stands a few miles south west of Gateshead <http://goo.gl/maps/xJgG2>. It crosses the river at an apparently skew angle, though the bridge itself is square spanning.

The first visible feature of note is the fact that the arch is built up of three independent rings. This is, of course, very common in brick bridges and was done in mediaeval times, but I don't think I have seen a bridge for the modern era built quite like this.

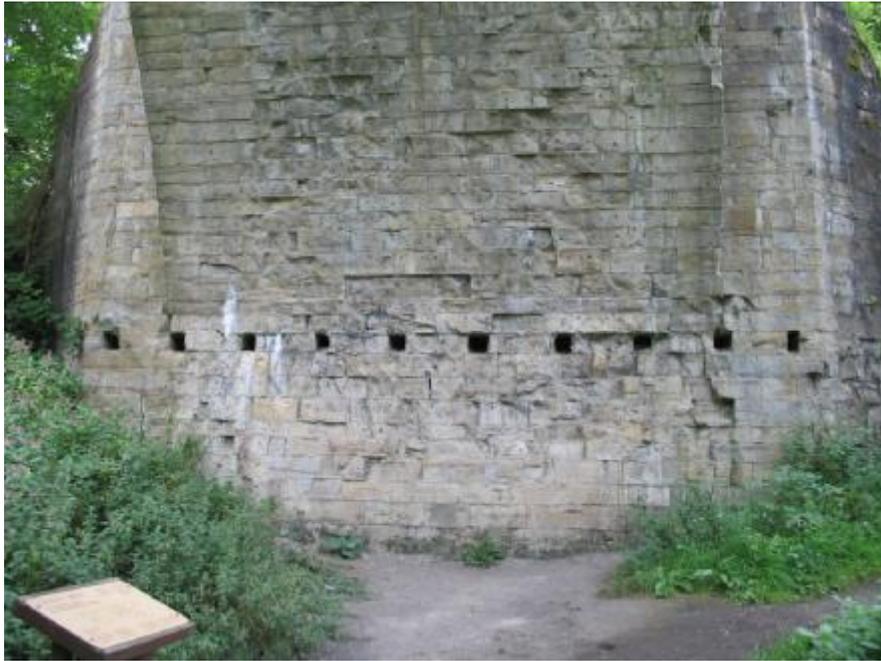
The engineer was clearly very brave, reaching out to a span much greater than any he could have seen. The centring alone must have been a major undertaking. There are putlog holes along the springing line of the arch which were presumably the location of the base of the springing. One feature of multi ring arches is that it reduces the load to be carried since the second and third ring are supported by the first while the centring must simply provide stability.

This picture also shows severe deterioration of the stone, which is, interestingly, concentrated beneath the arch and more or less absent at the edges.

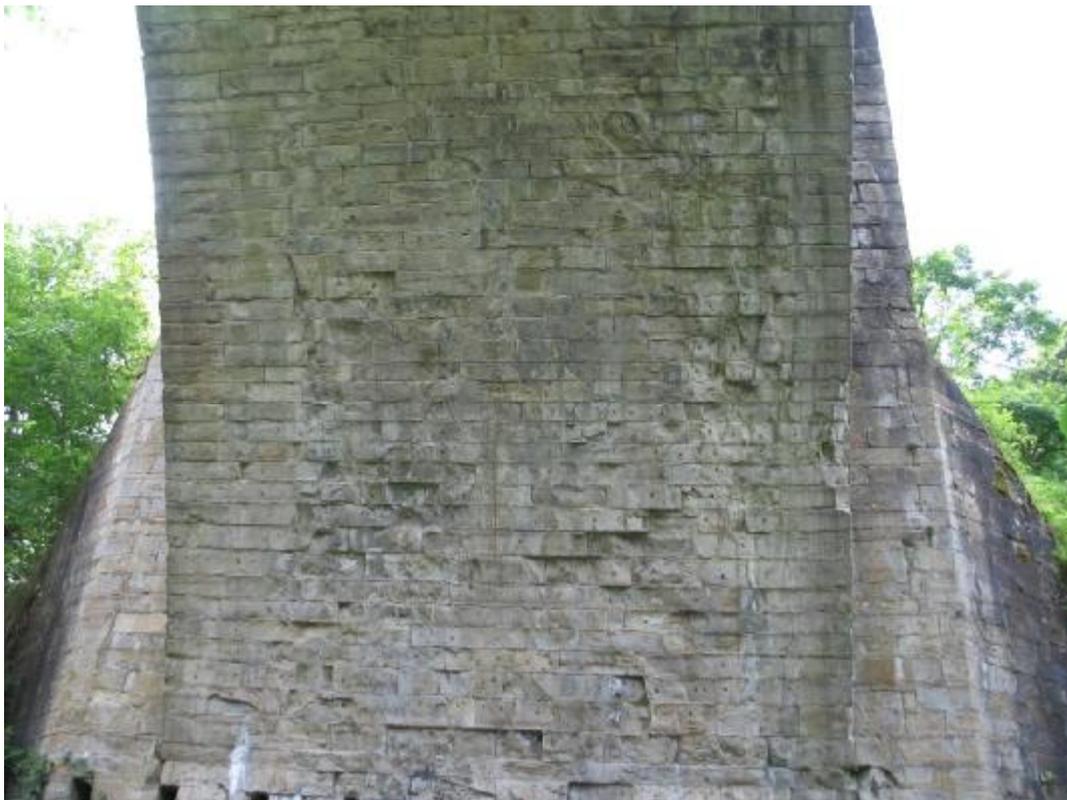
The damage extends upwards for some distance and then largely stops. There is similar damage near the arch crown and at the opposite springing.

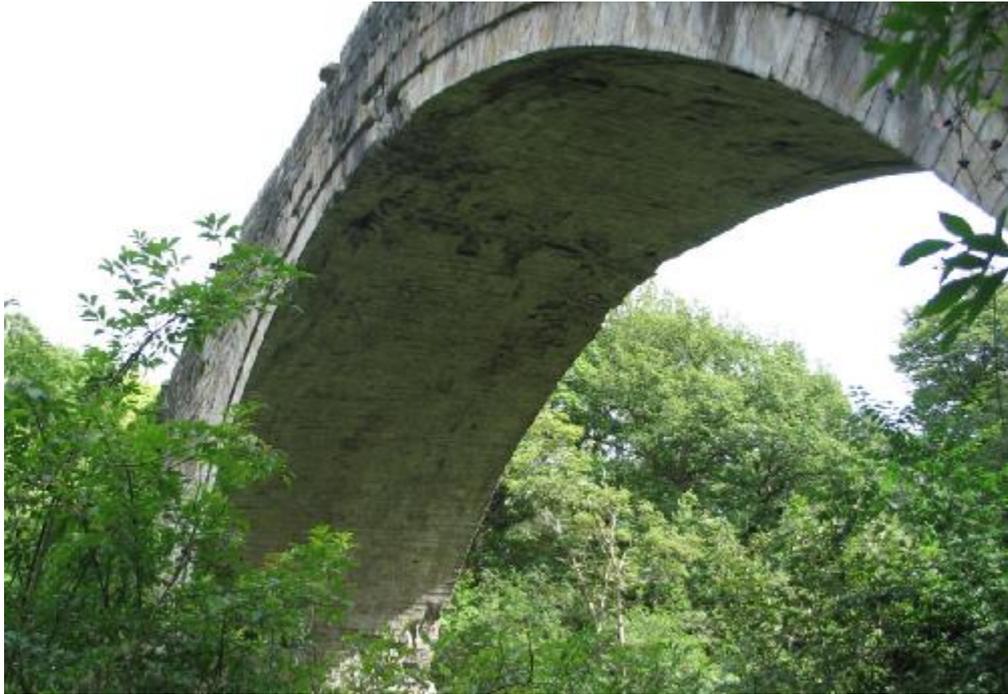
At the crown, the damage is even more interesting because it shows deep gouges separated by relatively sound stone. See also the detail below. It seems possible that this is an indication of hollow spandrel construction. The crown damage seems most unlikely to be caused by stress. If it were, the only possibility would be that the abutments had been pushed together. The damage is similar to that at the springings that it seems likely to be frost/water damage. The most likely way for that to accumulate at the crown would be if there were internal spandrel walls and a horizontal cap, when a slight sag in the arch would lead water falling on the bridge to gather near the crown and seep through.

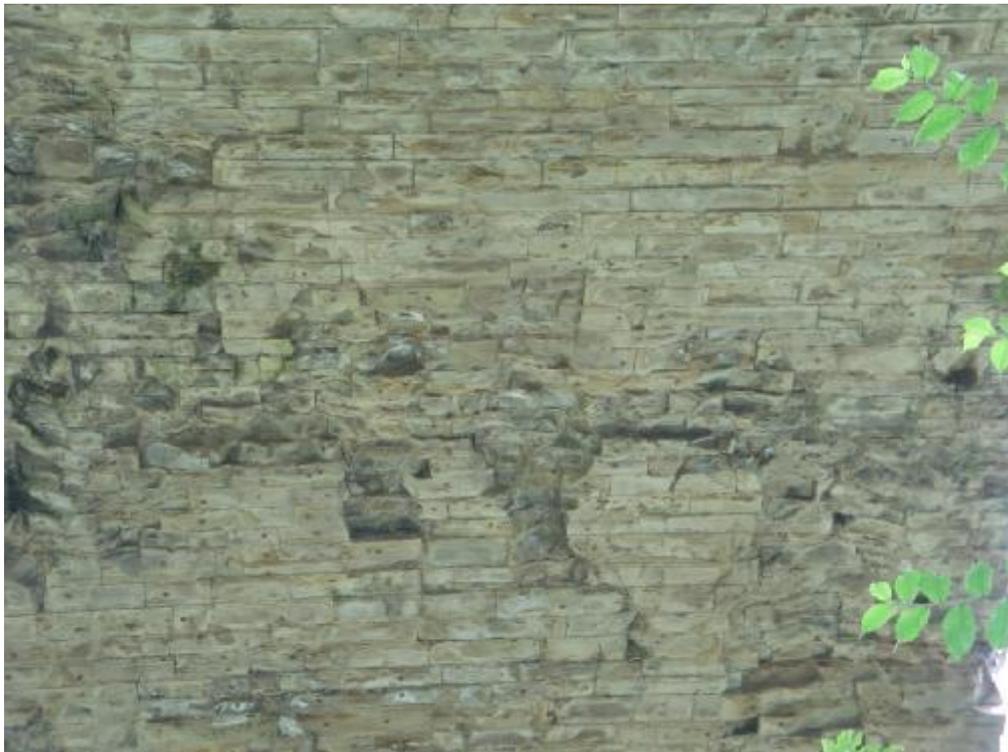
With a span of 30m and semi-circular form. The spandrel walls are about 17m high. To contain earth at such a depth they would need to be very thick, much thicker than the width of the bridge so the bridge would end up being solid masonry. That must be regarded as unlikely possibility.

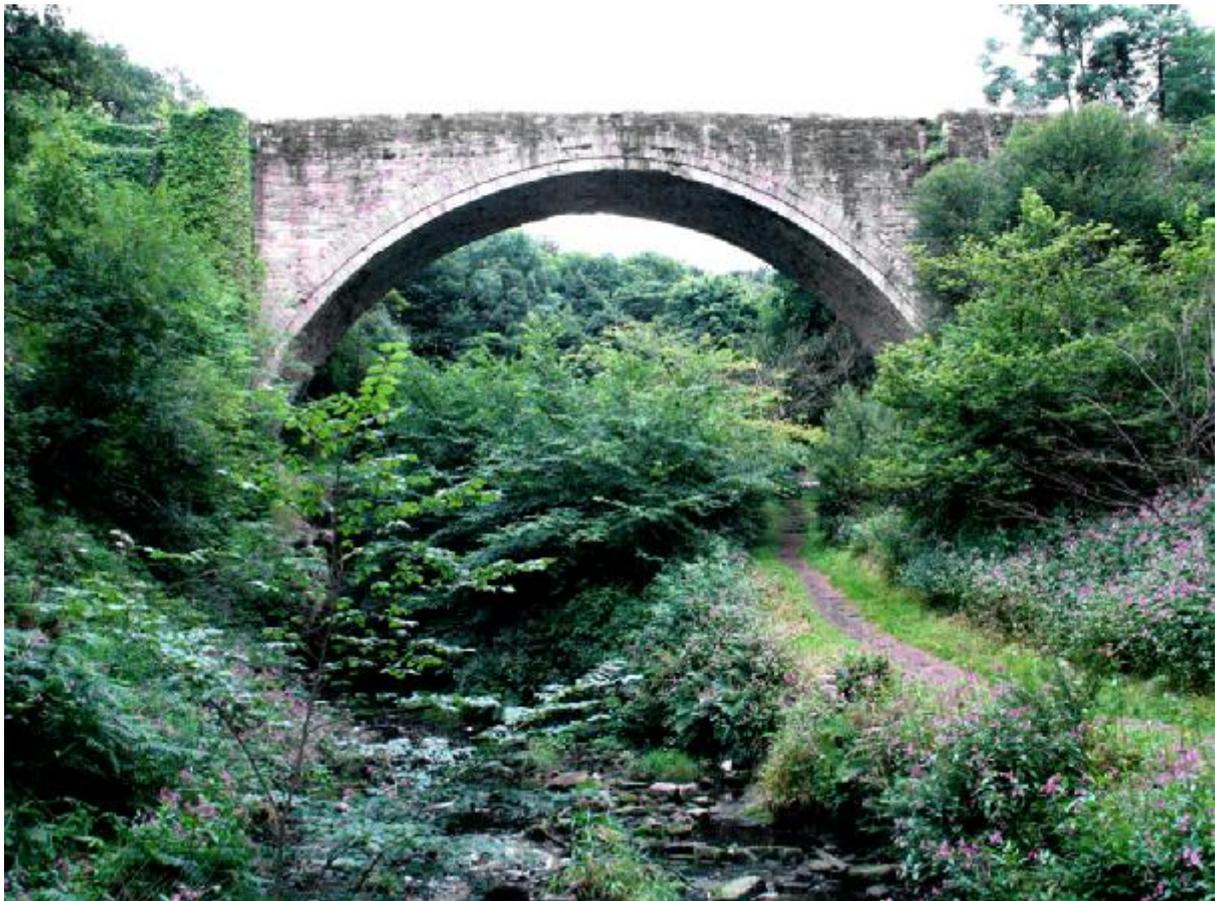
Photograph taken by John-Paul Stephenson on 11 August 2005. From Wikipedia Commons

The photograph below shows the full spandrel face and there is a clear division between wet stone near the top and drier below. This also suggests a flat topped, hollow spandrel construction.

It is interesting how the damage near the crown creates the impression of a pointed arch when the curve is actually quite smooth.
