Bridge of the Month No12 December 2011 Lugar Viaduct, Cumnock

Bill Harvey [Bill Harvey Associates Ltd](#) and [OBVIS Ltd](#)

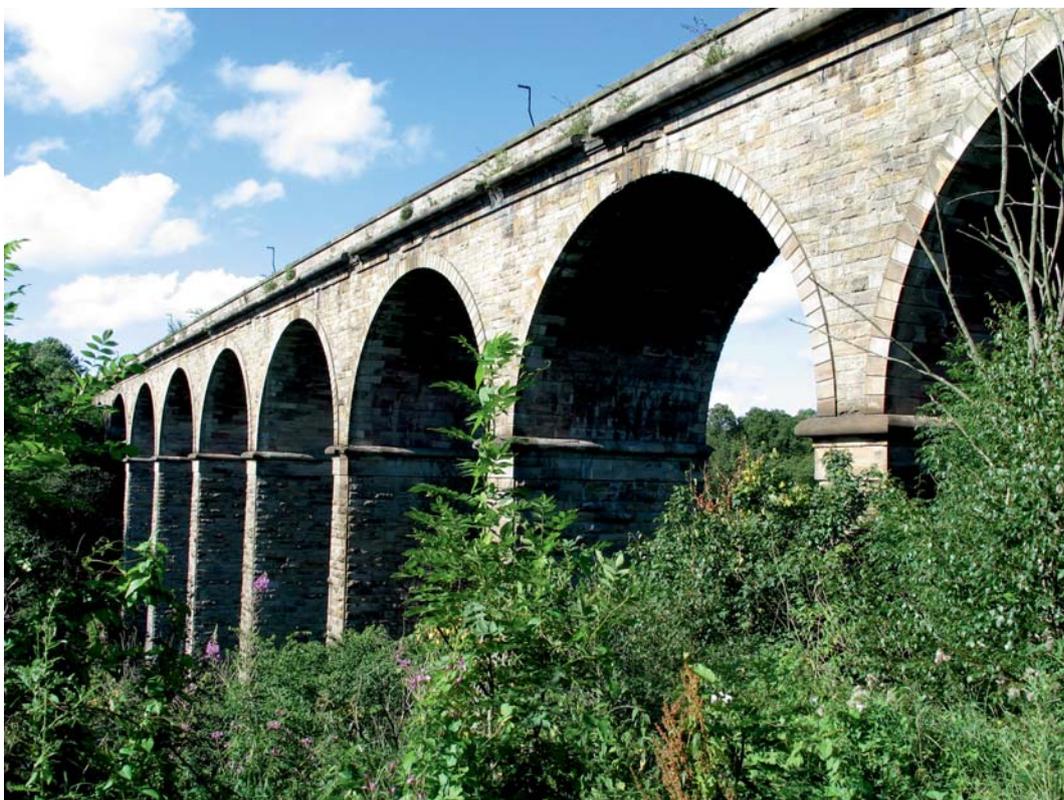
It is another viaduct on the Glasgow and South West Railway not far down the line from Ballochmyle, which appeared in March. John Millar designed the whole line with much repetition of detail and general construction. For example, the rolled string course forming a colossal drip check is common to all the bridges. It is now clear that all of Millar's under line bridges have internal spandrel walls. They have been found even in the standard access bridges which are only 12 ft (3.65m) span. His design was quite unusual in that the spandrels passed completely over the top of the arch and were then surmounted by slabs.

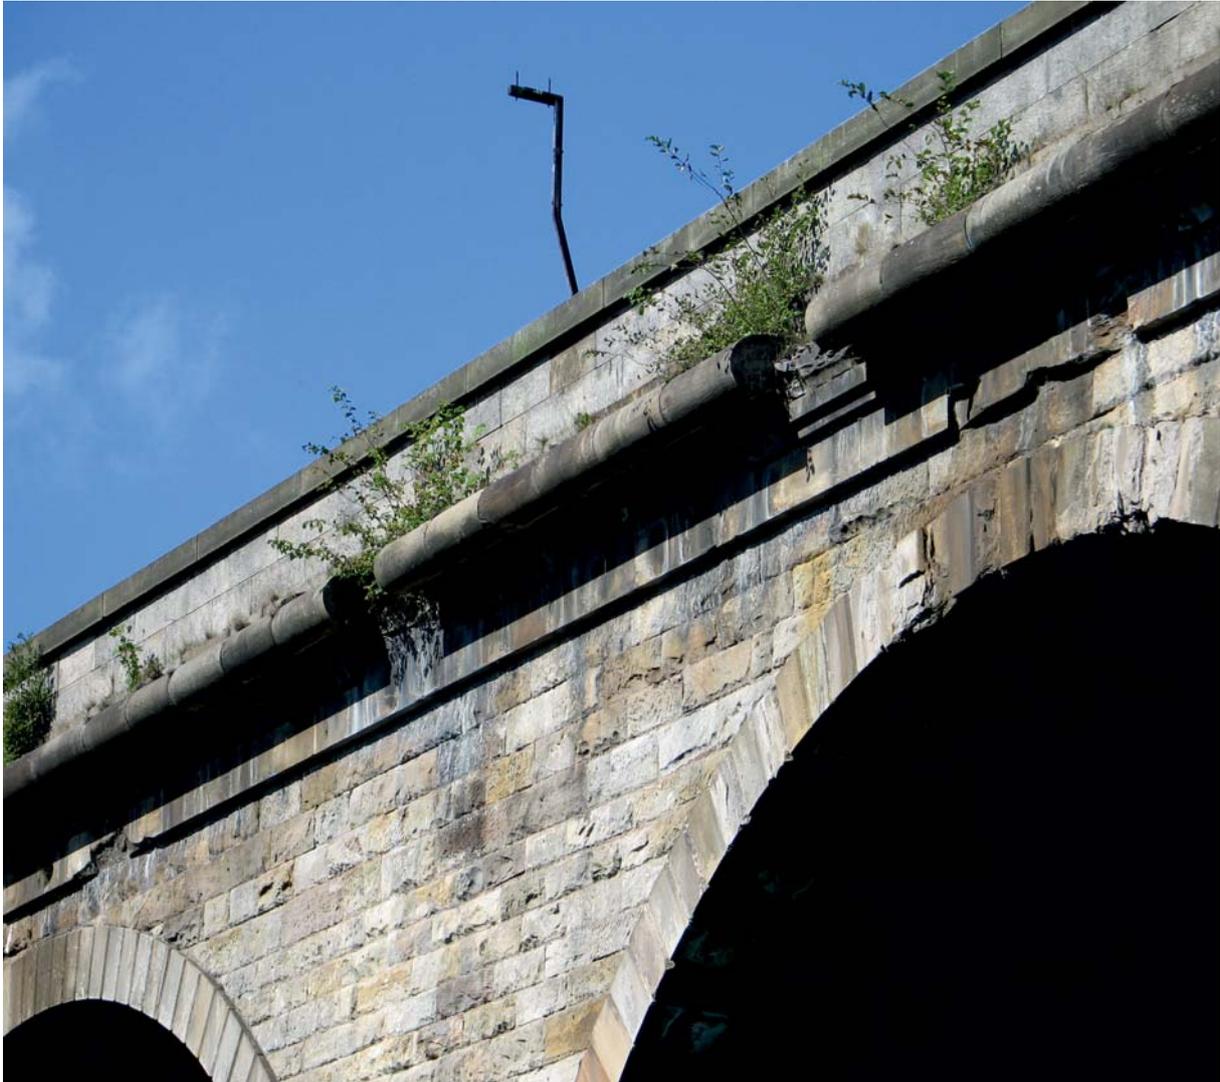
The scale of the stones used is clear from the nosings, some of which have broken off. The arch ring is about 30in thick and the nosings are only slightly smaller, perhaps 2ft thick, 3ft long and at least 3ft back into the wall to provide stability (see also the section on page 6).

One contributory factor in this construction is the quality of the stone readily available in the whole run of the line. I suspect that there was a certain amount of hauling but many of the bridges were built from stone quarried within a few hundred yards.

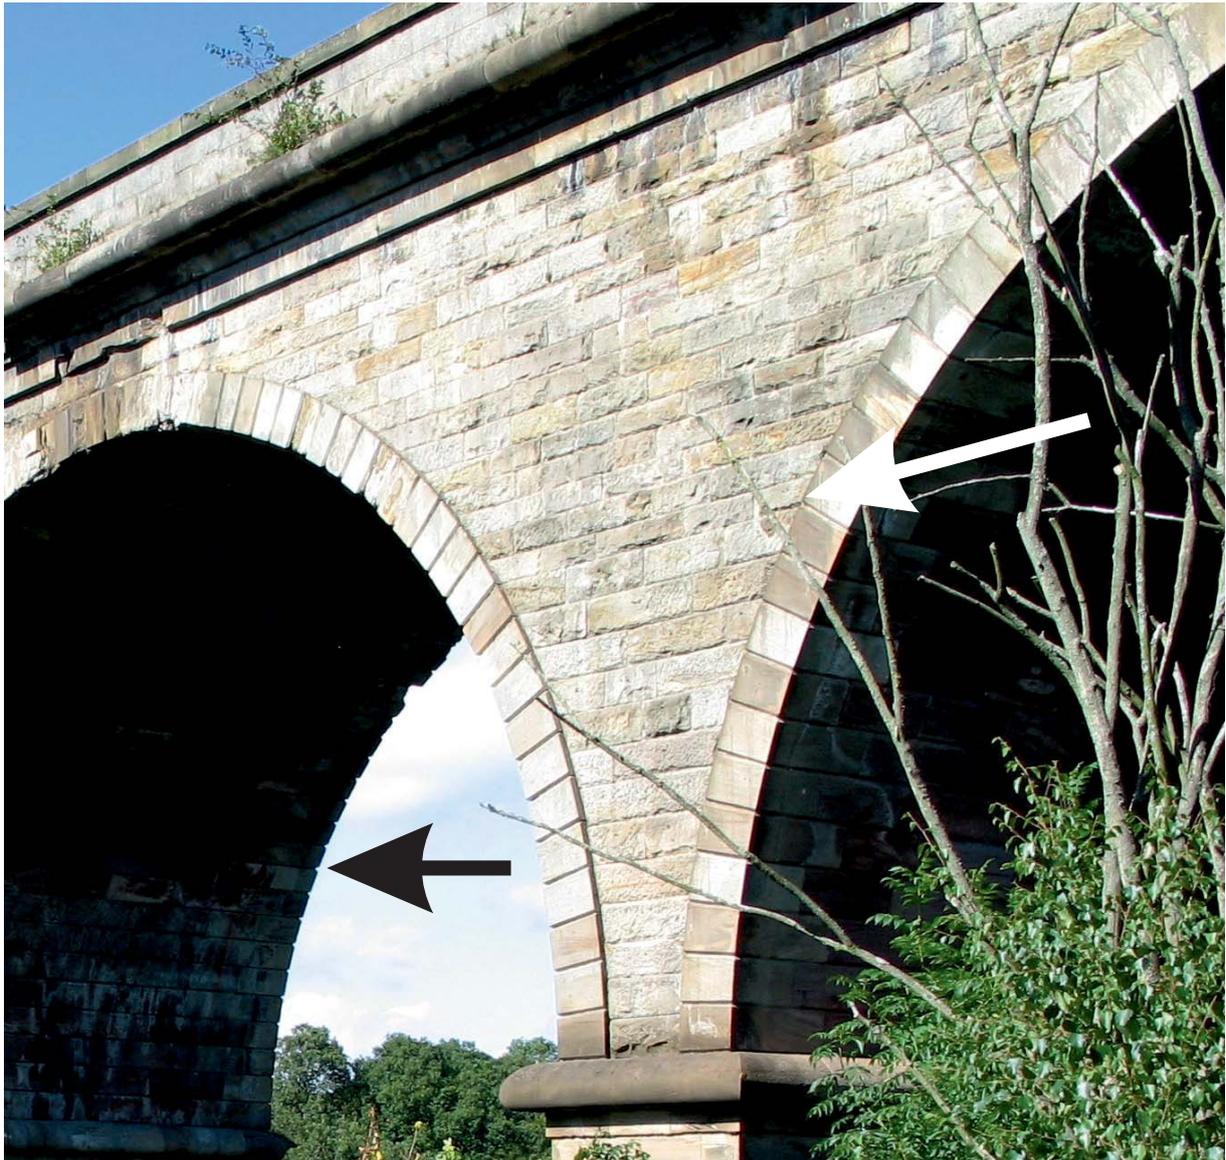
The arrows here mark the points where the construction changes. Both the spandrel wall and the arch soffit show different weathering above and below the line where the masonry is solid through. The upper level of the internal voids corresponds with the ashlar course below the (somewhat fractured) nose. Careful inspection of the first photograph will show that there are water runs on the surface of this ashlar which come from the top level of the deck slabs.

Closer inspection will almost certainly show banded weathering on the soffit indicating the outlines of the spandrel walls.

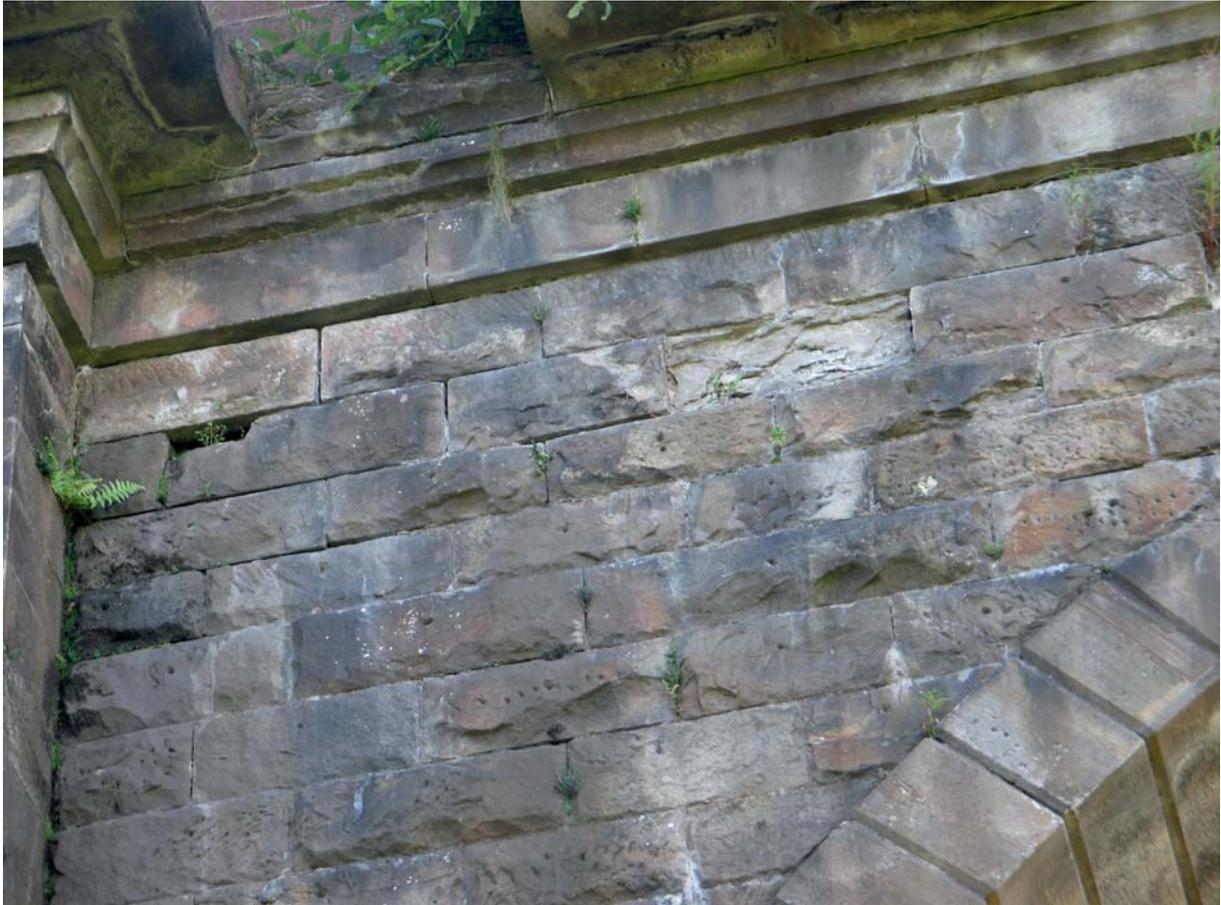
The stone was described by the masons as Freestone. In theory, that meant it could be cut and dressed in any direction but here we can see one stone which has been cut against the grain. Is that lack of skill on the part of the mason concerned, lack of care or even simply that when green the stone showed no real evidence of bedding?

Here you can also see the damage that ensues when water is allowed to run down the face without stop. The stone below the broken nosing is in rather worse condition than that which has been protected.

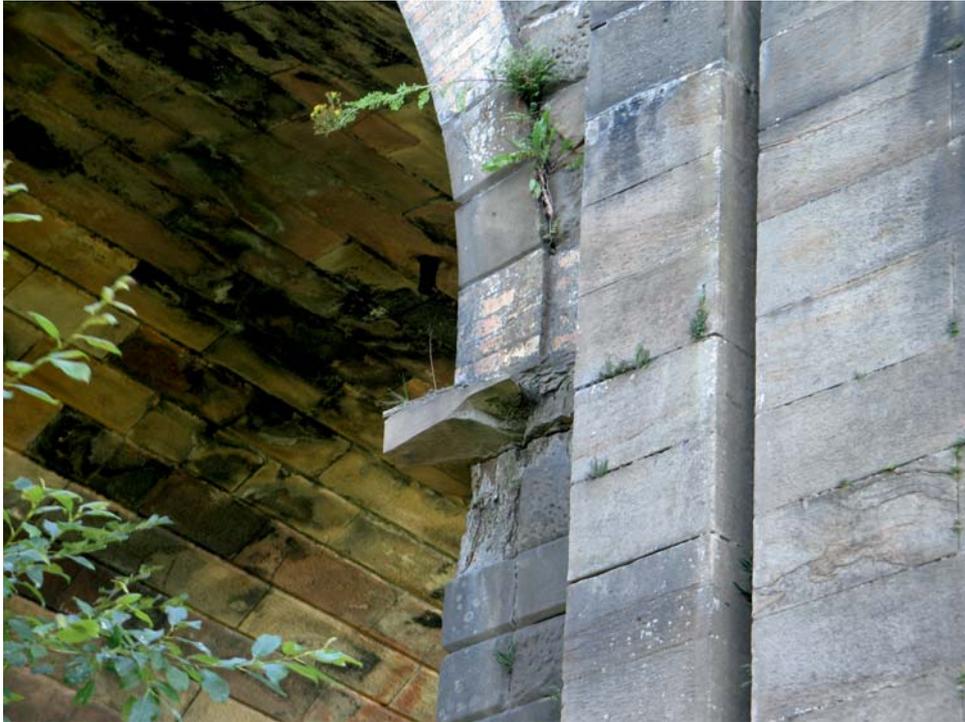
Here we see a drain at the arch crown, which is a strange idea if you do not realise that the deck is a notionally flat slab which will necessarily drop at mid span after decentring. There is a very wet stripe below the drain which might be splash from the drain itself or might be showing the line of the central void.

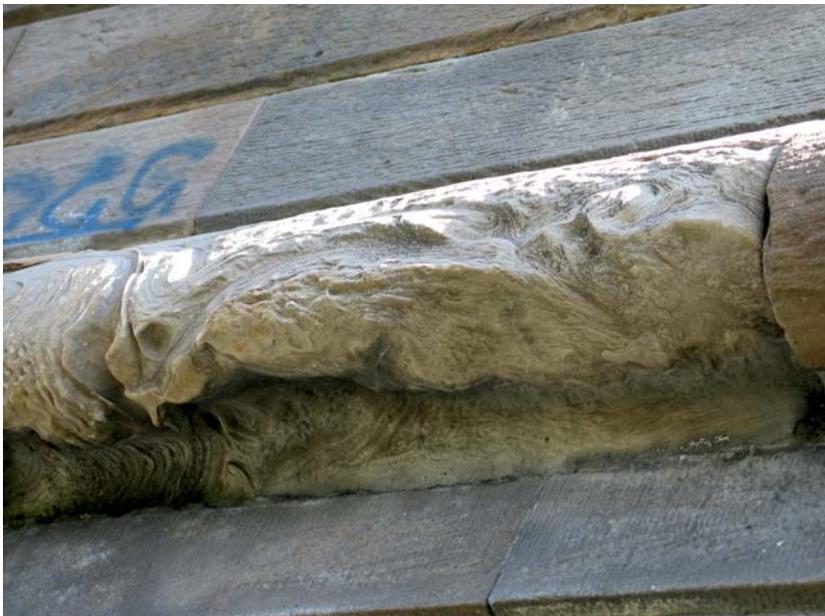
This beautifully weathered stone is included particularly for Heather Jackson of the National Museum of Wales. We had a heated discussion over Christmas about whether the main value of rock was that it was a good material for building bridges or the main value of stone bridges is that they show off stone to the best advantage. Strange that in this whole bridge there should be just one example of such a weathered piece.

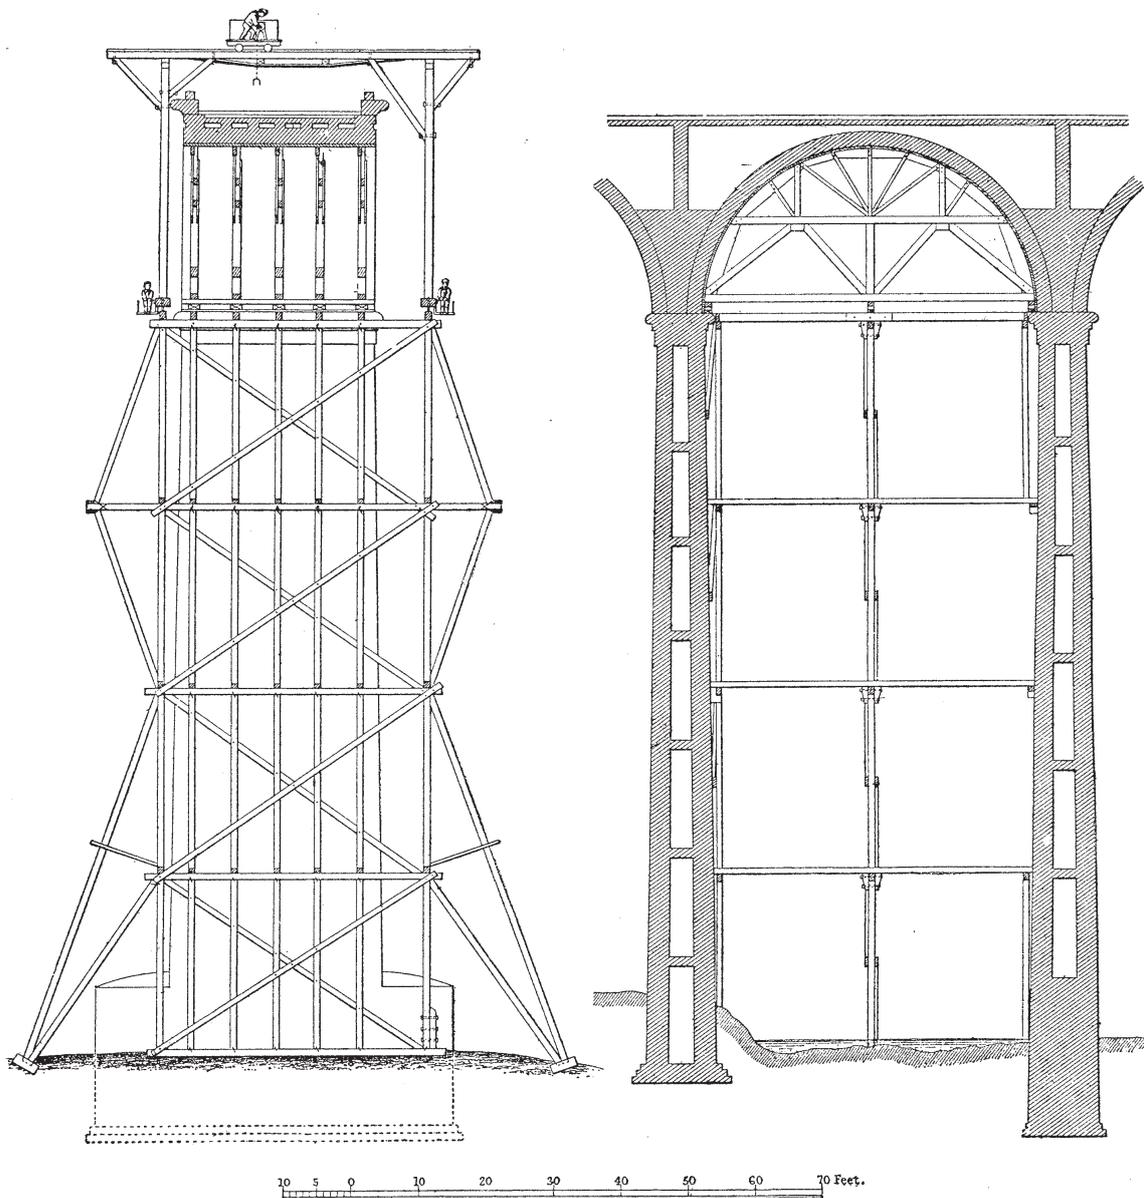
And now it is time to look at those drawings. They were clearly intended first to illustrate the timber work of the centring. The scale of the timbers is spectacular, 12" square sections up to 60 feet long (0.3x0.3x18.3m). The timber gantry crane was 40 feet high and must have swayed alarmingly as the winch man wound up the large stones.

The centring itself is in two completely independent sections. A table is formed at half height of the arch with a very simple truss and a lighter and more complex frame sits above to carry the main part of the span. Unfortunately, there are no details of the wedges that carried the centre and allowed it to be dropped.

Note that the cross section shows six letterbox openings over the crown. So 5 internal spandrel walls. I think I need to run this on into next month and say rather more about the construction, the stiffness and the potential for deterioration.

Many years ago (I can't remember when now but before 1990) I was walking across Glasgow from the University to the station when I happened on a second-hand book shop. I scanned it with only about 10 minutes to spare and found, in that short time, a volume of the *Modern Carpenter and Joiner and Cabinet Maker* (Volume 6 published by Gresham in 1903) which included a chapter on bridge construction. It happens that this volume includes drawings of the centring for Lugar which also shows the detail of the internal construction.

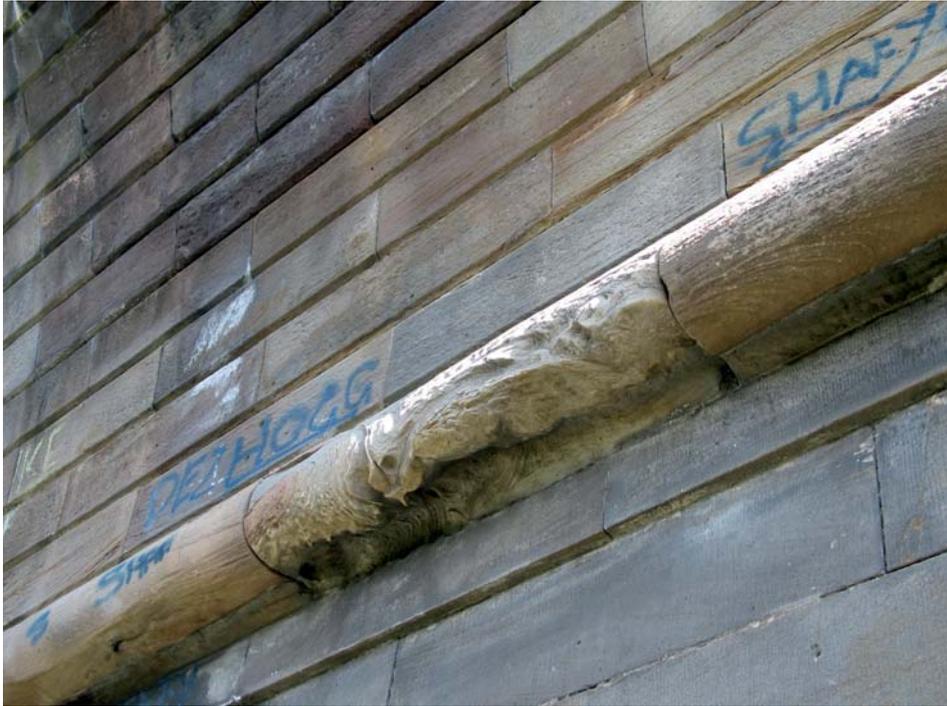
One last picture to show how the weathered stone stands alone in the structure. Clearly a function of the stone rather than the environment.
